**113031**

## **INTERIM ENVIRONMENTAL MANAGEMENT PLAN FOR SANDERS RESERVE, SANDERS PARADE, CONCORD**

**ENVIRONMENTAL EARTH SCIENCES NSW**  
**REPORT TO CITY OF CANADA BAY**  
**DATE APRIL 2013**  
**VERSION 2**

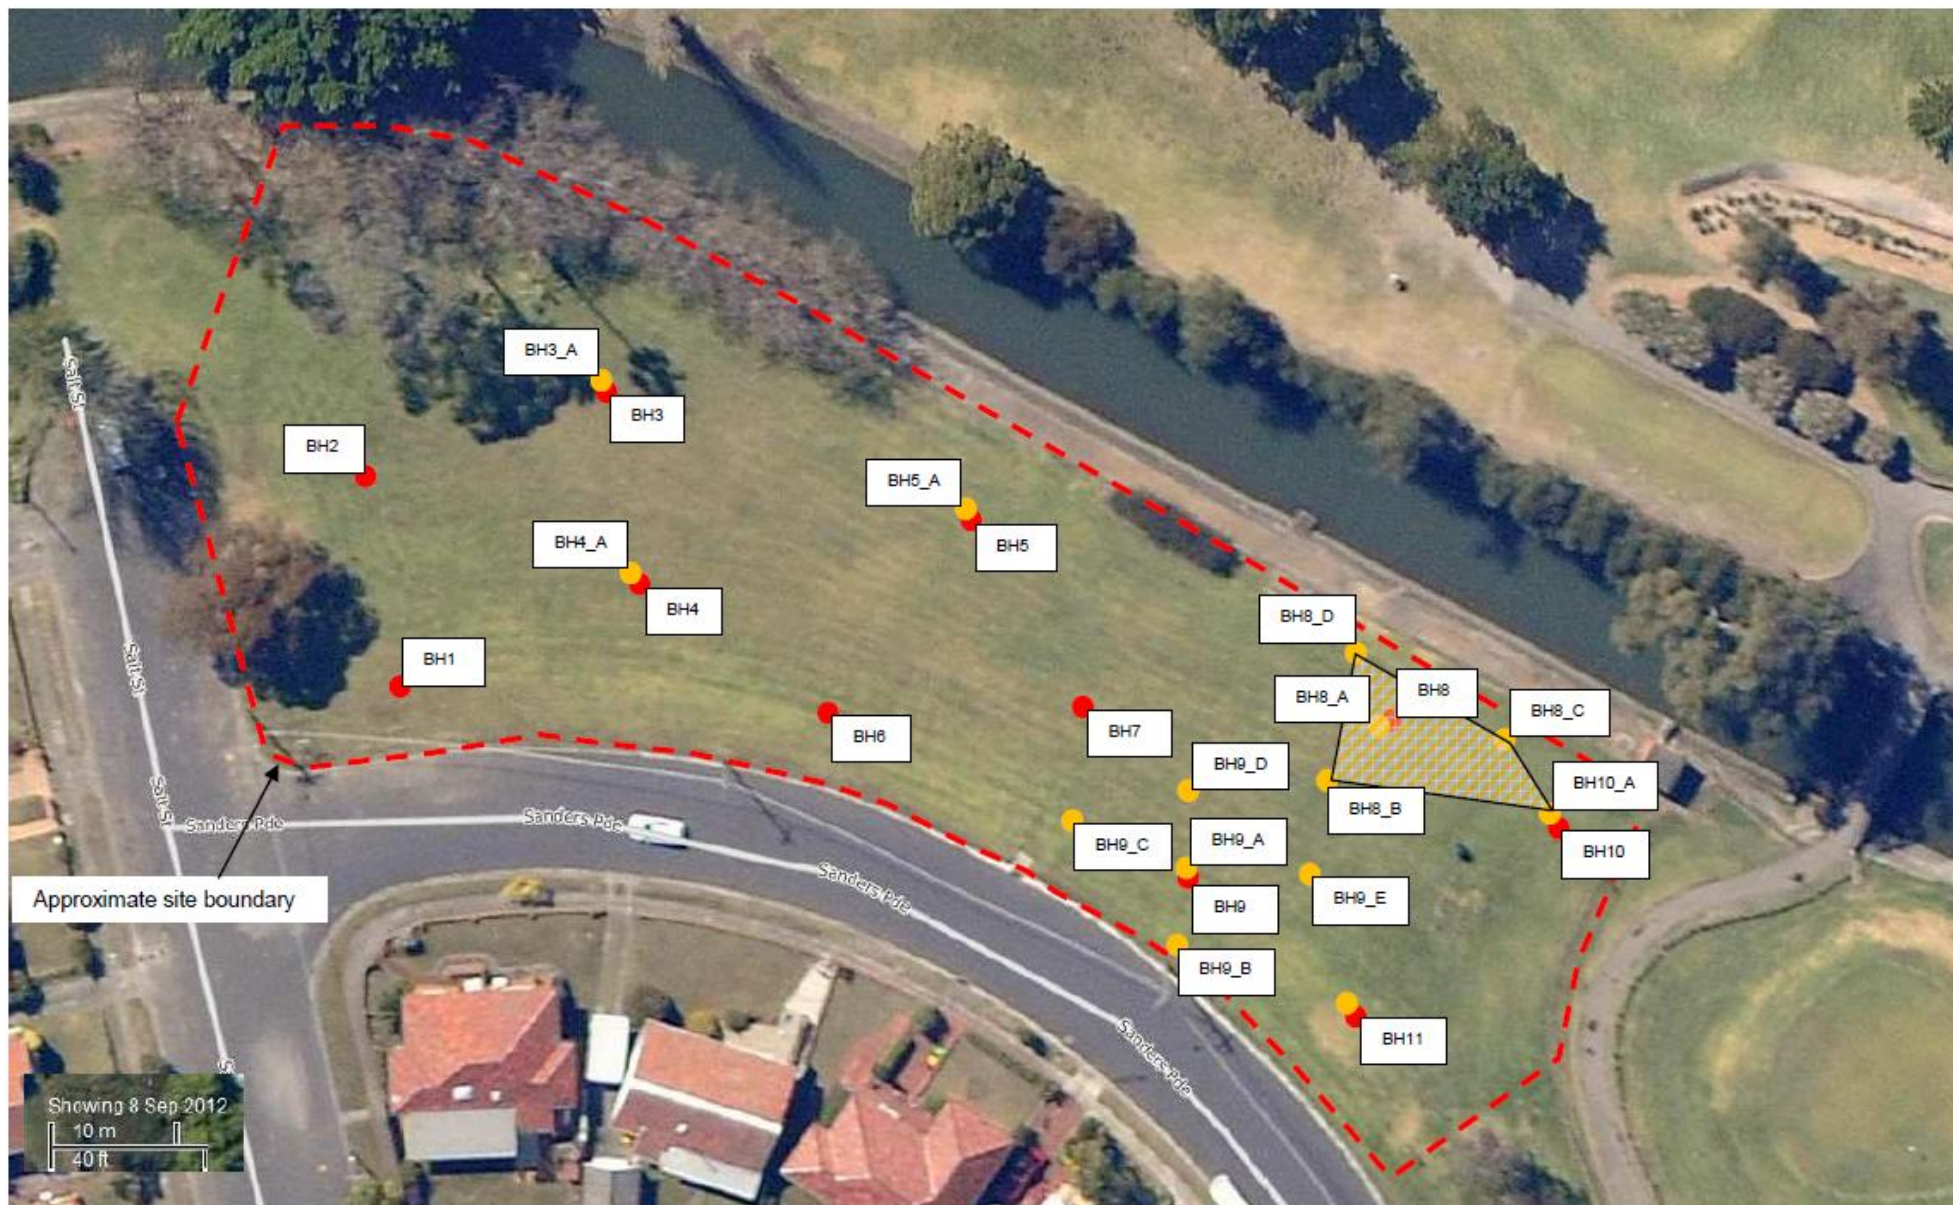
Title: <b>Sampling locations</b>	
		Location: <b>Sanders Reserve, Concord</b>	
Client: <b>City of Canada Bay</b>		Job No: <b>112094</b>	
Drawn By: <b>NC</b>	Scale: <b>As Shown</b>	Source: <b>Nearmap</b>	
Proj Man: <b>CM</b>	Date: <b>Dec 2012</b>	<b>Figure 2</b>

Sanders Reserve is a public park located between Saltwater Creek in the north (a lined open stormwater channel) and Sanders Parade in the south (See Figure 1 and 2). East of the park is part of the Massey Park Golf Course while to the west is the northern cul-de-sac of Salt Street. The park situated in a predominantly residential area and is accessible to the public. At present the site is mainly open turf with a few stands of trees – particularly in the north-western corner.

Unfortunately the barrier itself was found to contain a sample of soil with asbestos present in it (BH8\_0.3m). The asbestos was found at 0.3 metres and subsequent testing of the surrounding area has shown that the impact is not present at this surface in this location nor were any other instances of asbestos impacted soil discovered in samples analysed elsewhere in the cap.
