Metalwork

Introduction

This information sheet deals with the care and conservation of metals used in building, including cast and wrought iron as fencing and decorative panels, steel-framed windows and roof plumbing. For further information refer to the references at the end of the sheet, and to the separate information sheets on *Corrugated Roofing*, and *Slating, Tiling and Roof Plumbing*.

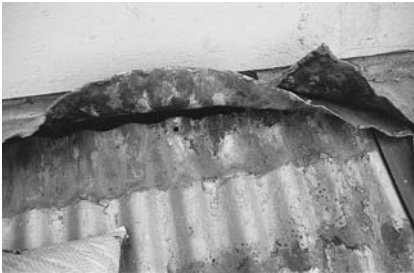
Galvanic corrosion of original corrugated metal sheeting.

Galvanic corrosion occurs between dissimilar metals. If two such metals are in electrical contact in an electrolyte (or conducting solution) such as water, one of the metals will corrode at a faster rate than it would normally, and at the same time the other metal will be protected from corrosion. A less noble metal in the **galvanic series**, shown here, will corrode preferentially and protect a more noble metal (one higher in the series). This is the principle behind the galvanising (or zinc coating) of steel: the zinc corrodes preferentially and protects the steel.

The further apart two metals are on the series, the greater will be the galvanic reaction. Combining two distant metals in a damp environment will lead to rapid corrosion of the less noble metal. This is why metals such as zinc (or galvanised steel) and copper should never be used together. Lead flashings and cappings, traditionally used in conjunction with galvanised steel roofs, can cause corrosion if the roofing is replaced with modern steel sheeting coated with a zinc–aluminium alloy.

Even if the two metals are not touching, corrosion can still occur. Water can provide an electrical bridge, or carry in solution a small amount of the nobler metal to the other, where it precipitates or plates out and causes corrosion. Thus, water running off a copper roof into galvanised gutters will lead to rapid corrosion of the zinc galvanising and then the steel of the gutters.

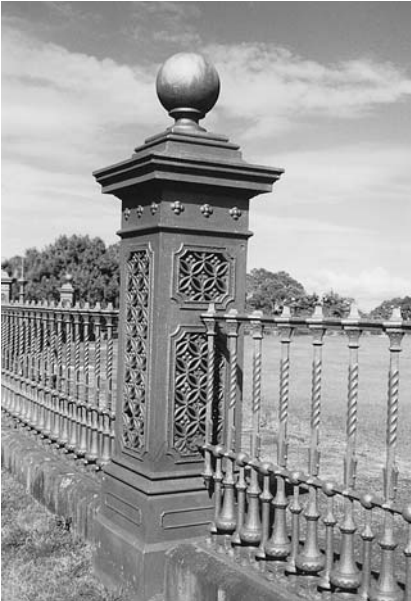
Ornate palisade fence, Centennial Park reservoir, Sydney.

A common conservation measure needed for palisade fences is to replace stays that may have been misguidedly removed to allow easier access for lawnmowers and the like. The stays are needed to brace the fence and ensure its lateral stability.

Crevice corrosion can occur where the shafts penetrate the rails, and also between the spearheads and the top rail. Careful filling and painting of these areas is required to eliminate crevices where corrosion may occur.

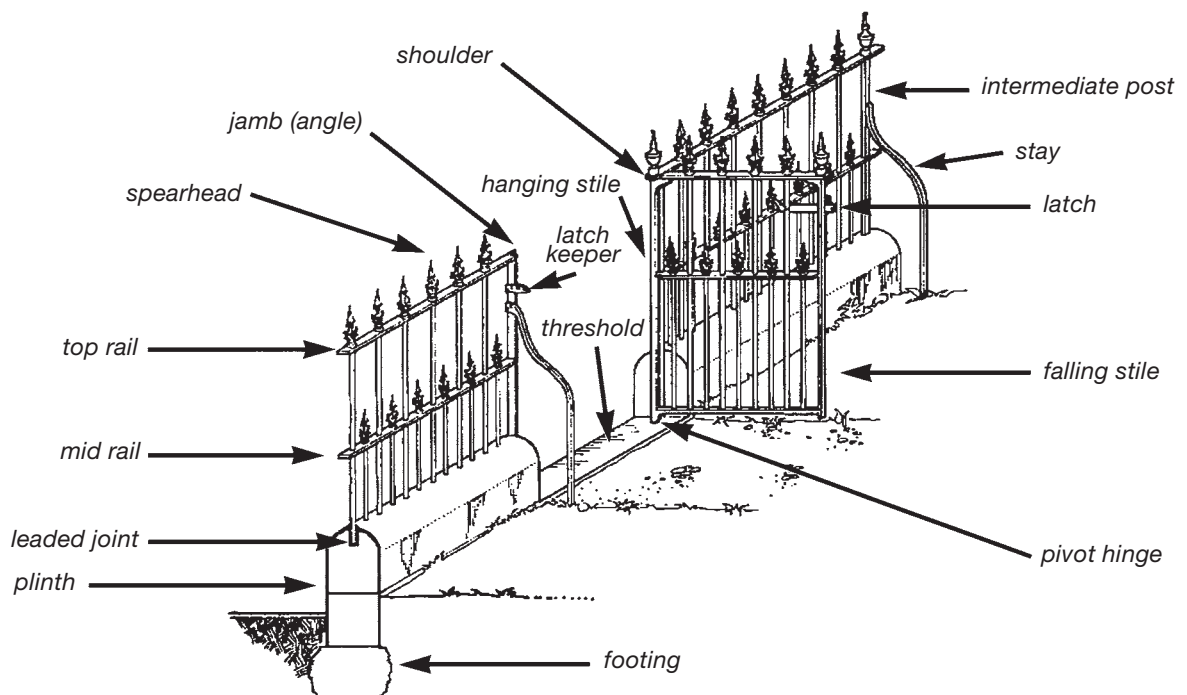
Iron Palisade Fence Construction

The problem with such fixings is that repeated thermal cycling creates a very small gap between the iron and the lead, allowing water entry and consequent crevice corrosion. Severe corrosion of the iron can result in rupturing of the masonry base as the rusted metal expands.

- removing the shafts, treating them for rust, and replacing them according to traditional practice with molten lead;
- removing the shafts, treating them for rust, and replacing them with a modern packing such as expansive tape;
- cutting off the corroded base and welding on a new base of mild steel, galvanising the whole shaft, and resetting it in lead;
- cutting off the corroded base and welding on a new base of stainless steel, which is then set in lead or in expansive tape. If lead is used it will be the less noble metal and will therefore corrode;
- cutting off the corroded base to a stump and fastening a new base of stainless steel tubing over the stump using epoxy adhesives. The outside diameter of the tubing must match that of the shaft. The tubing can then be set in lead or in expansive tape;
- replacing the entire palisade in new galvanised steel painted an appropriate colour.

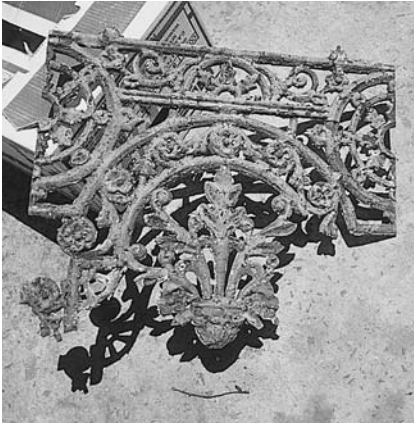
Remnants of cast iron lacework can be used to identify original patterns.

Decorative ironwork, such as iron lace of the 19th century, was almost all cast iron, which developed from earlier, elaborately shaped wrought iron work. Conserving cast iron lace often requires replacement of missing sections, or sometimes complete reconstruction of a verandah long since removed. The original pattern of the cast iron may be found by careful searching of the site for remnants of the original material, examining early photographs, or inspecting adjacent identical buildings, such as in a terrace. Spacings of columns, uprights and rails can often be determined by looking for evidence of fixings in floors, pavements or walls.

Foundries can reproduce ironwork using existing pieces as patterns, although care is required because slight shrinkage occurs when the iron cools. A better result may be obtained by producing a new pattern for the casting.

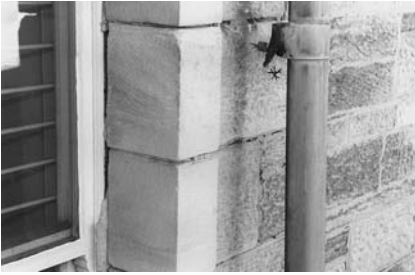
Loose fixings.
