BAYVIEW PARK

PLAN OF MANAGEMENT

Prepared for
Concord Council

by
Connell Wagner

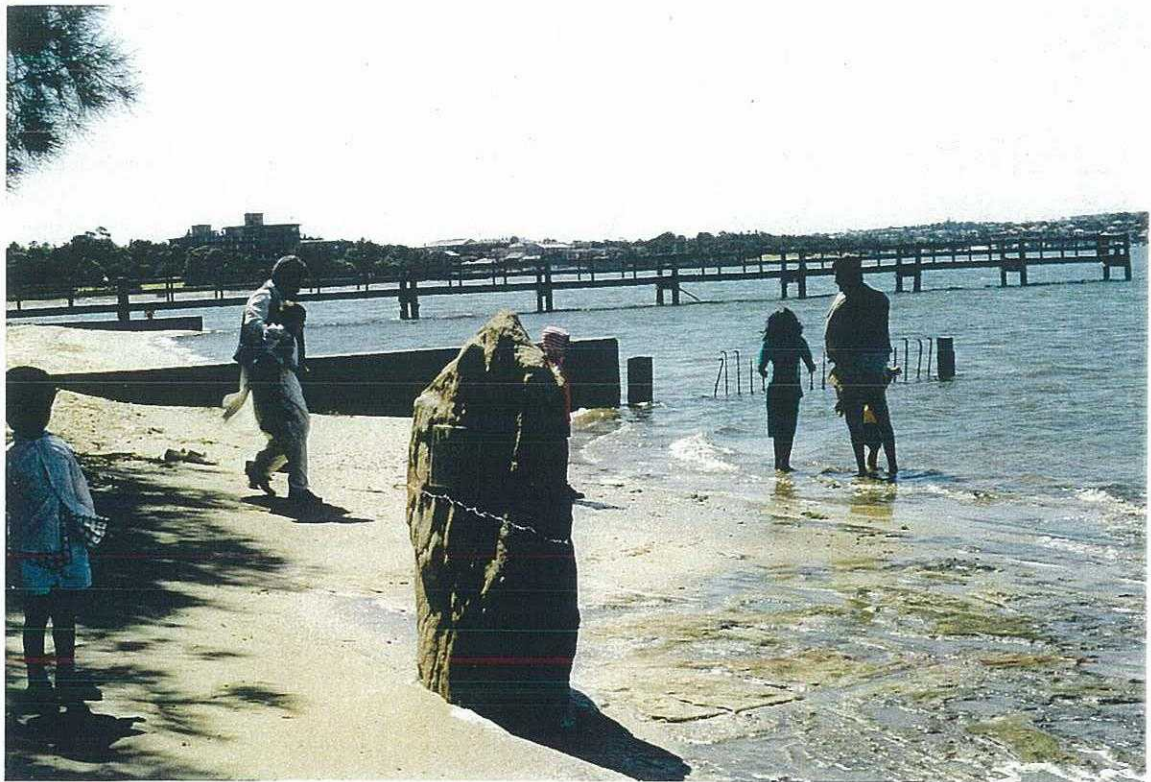
Eastern Beach showing wharf and remaining sections of Bayview Baths.

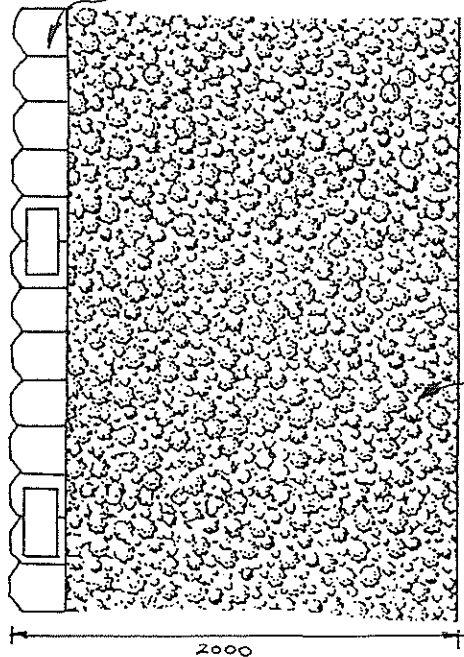
Foreshore Promenade
(Southern Section)

concrete edge to match
adjacent path - heritage
plaques, set along edge

concrete
edge to
match
other

tan
coloured
bitumen

exposed
aggregate
concrete
to match
adjacent
path

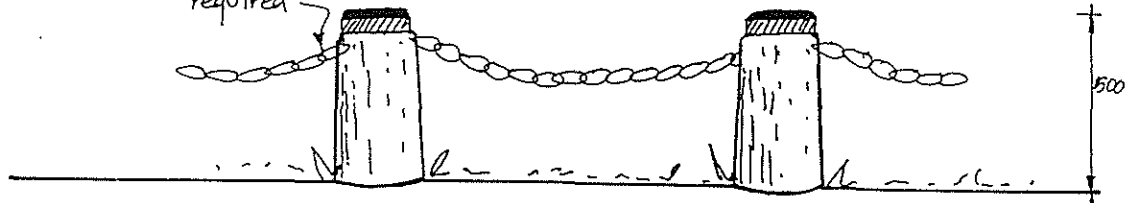
Car Park Barrier Fence

marine motif fence
around car park as
required

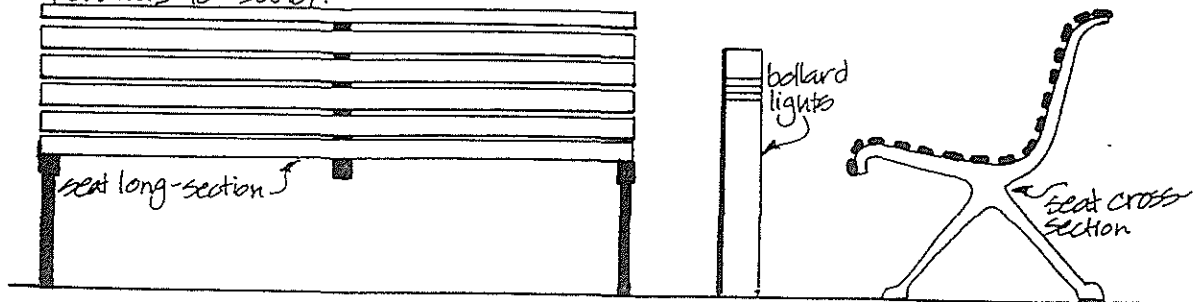
Seating/Lighting

seats bollard lighting & other lights
to match/complement adjacent
Pathway to south.
